UNITED STATES ENVIRONMENTAL PROTECTION AGENCY  
REGION 5

SUBJECT: INSPECTION REPORT – Tech Nickel, Inc., Benton Harbor, MI

Date of Inspection: August 12, 2013

Purpose of Inspection: The purpose of the inspection was to investigate compliance of Tech Nickel Inc. with the National Emission Standards for Hazardous Air Pollutants for Chromium Emissions From Hard and Decorative Chromium Electroplating and Chromium Anodizing Tanks at 40 C.F.R. Part 63, Subpart N and the National Emission Standards for Hazardous Air Pollutants for Plating and Polishing Operations at 40 C.F.R. Part 63, Subpart WWWW.

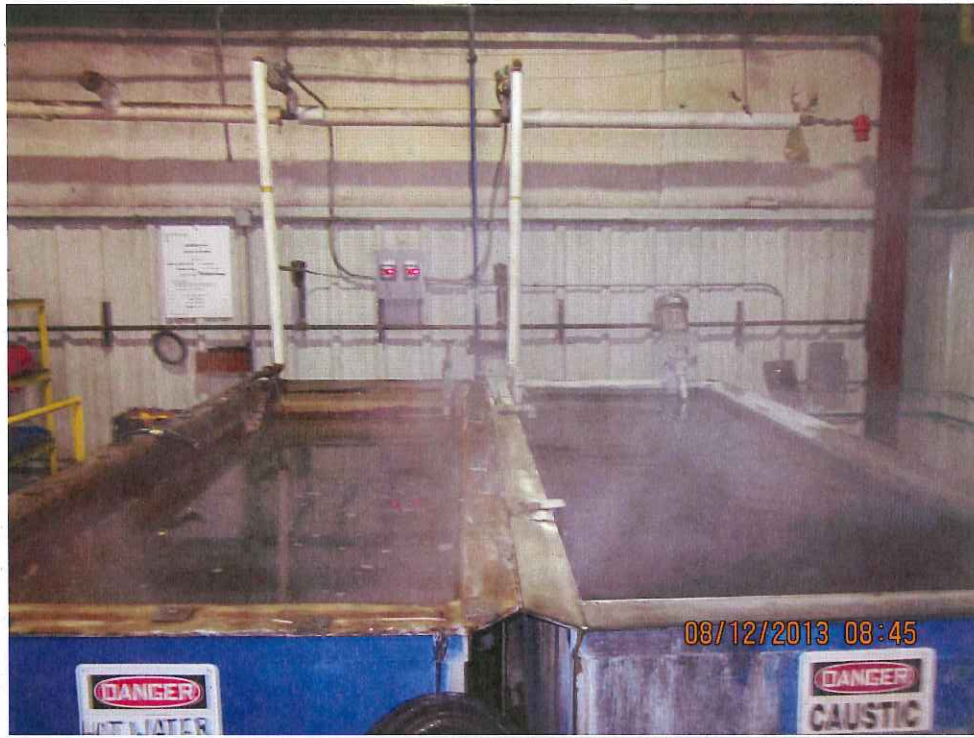
Ms. Brahmbhatt and I first observed two hot alkaline cleaner tanks, both were covered. I asked Mr. Vogl if I could photograph the tanks. Mr. Vogl consented and removed the Styrofoam covering (Photo 1 and 2).

Photo 1: Tech Nickel's hot alkaline cleaner tanks.

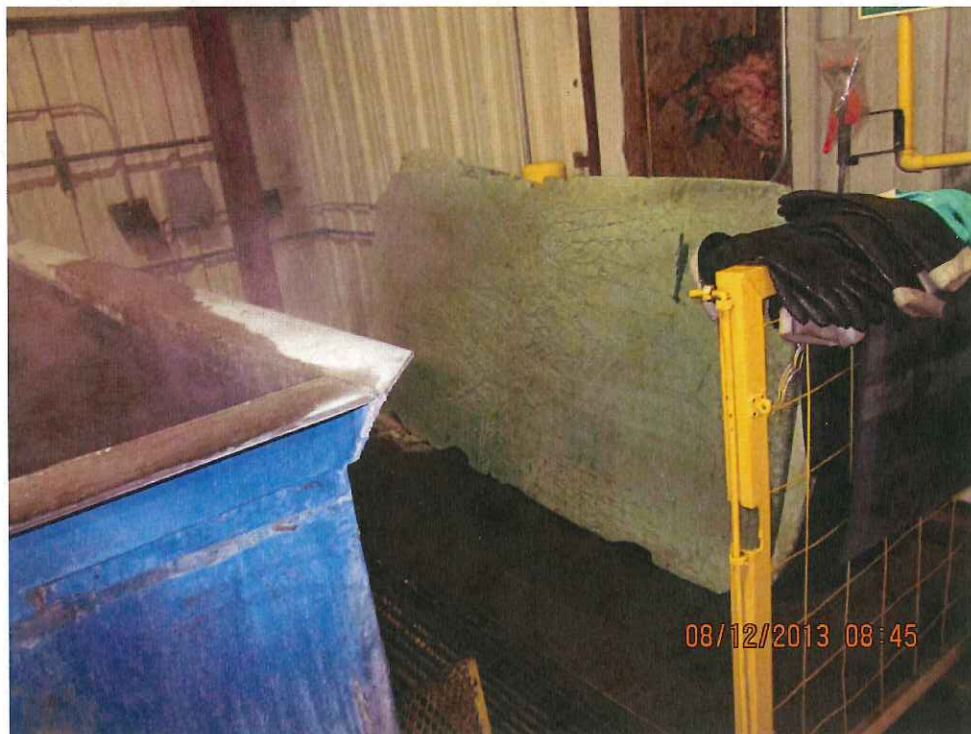
Photo 2: A close up of the cover for Tech Nickel's hot alkaline cleaner tanks.

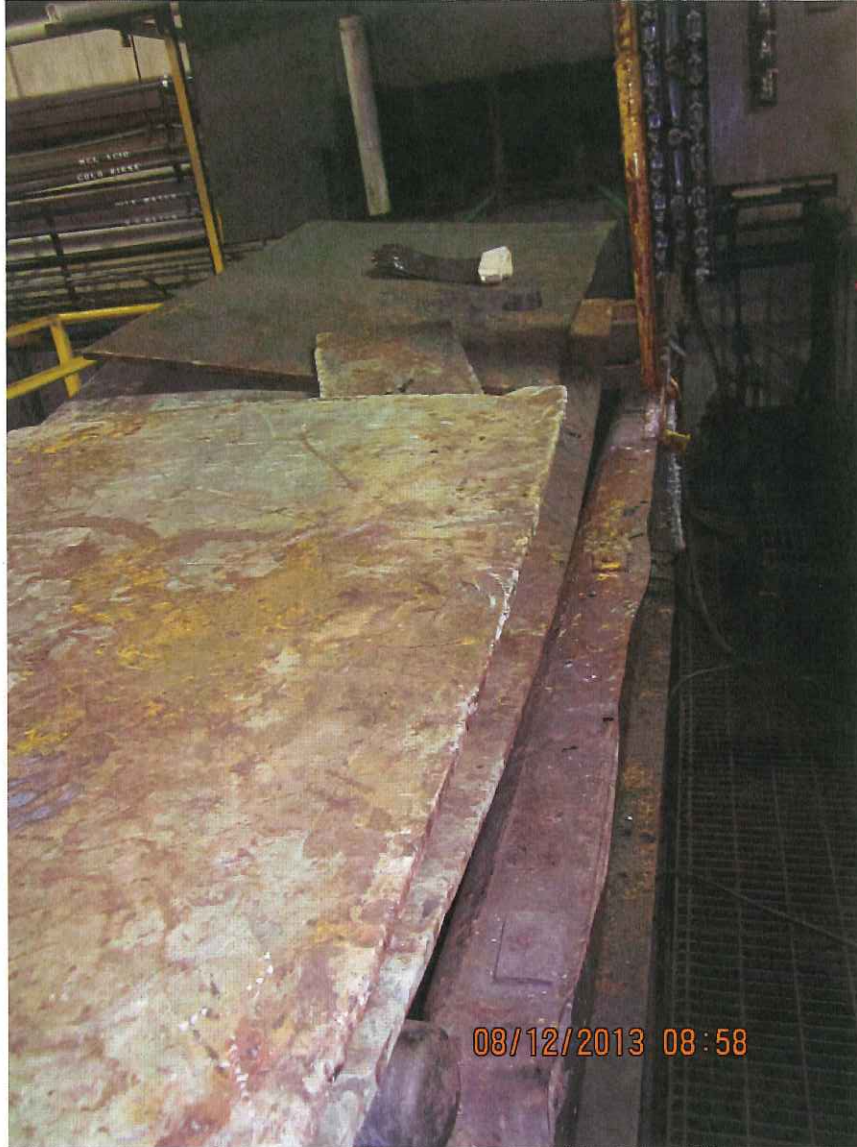
Vogl pointed out the hydrochloric acid tank. Ms. Brahmabhatt and I observed the hydrochloric acid tank which was covered with a foam-like board, the size of the tank (Photo 3). Next we walked down the plating line to the chromium tanks. Ms. Brahmabhatt and I asked Mr. Vogl if the chrome plating tanks had specific names. Mr. Vogl stated that the chrome plating line consisted of three tanks: 'J,' 'K,' and 'L' from left to right. Mr. Vogl stated that 'J' is an evaporation tank where Tech Nickel deposits its waste water to evaporate prior to sending to the scrubber. Mr. Vogl stated that 'K' is the small hexavalent hard chromium tank used for small pieces which are plated for approximately 30 seconds (Photo 4). Mr. Vogl stated that 'L' is the large hexavalent hard chromium tank (Photo 5). Ms. Brahmabhatt asked for the location of the Magnehelic gages on the chromium line. Mr. Vogl pointed out the gages for the chromium tanks which were situated between tanks 'K' and 'L' and were approximately 10 feet off the ground (Photo 6).

Photo 3: Tech Nickel's hydrochloric acid tank with covers.

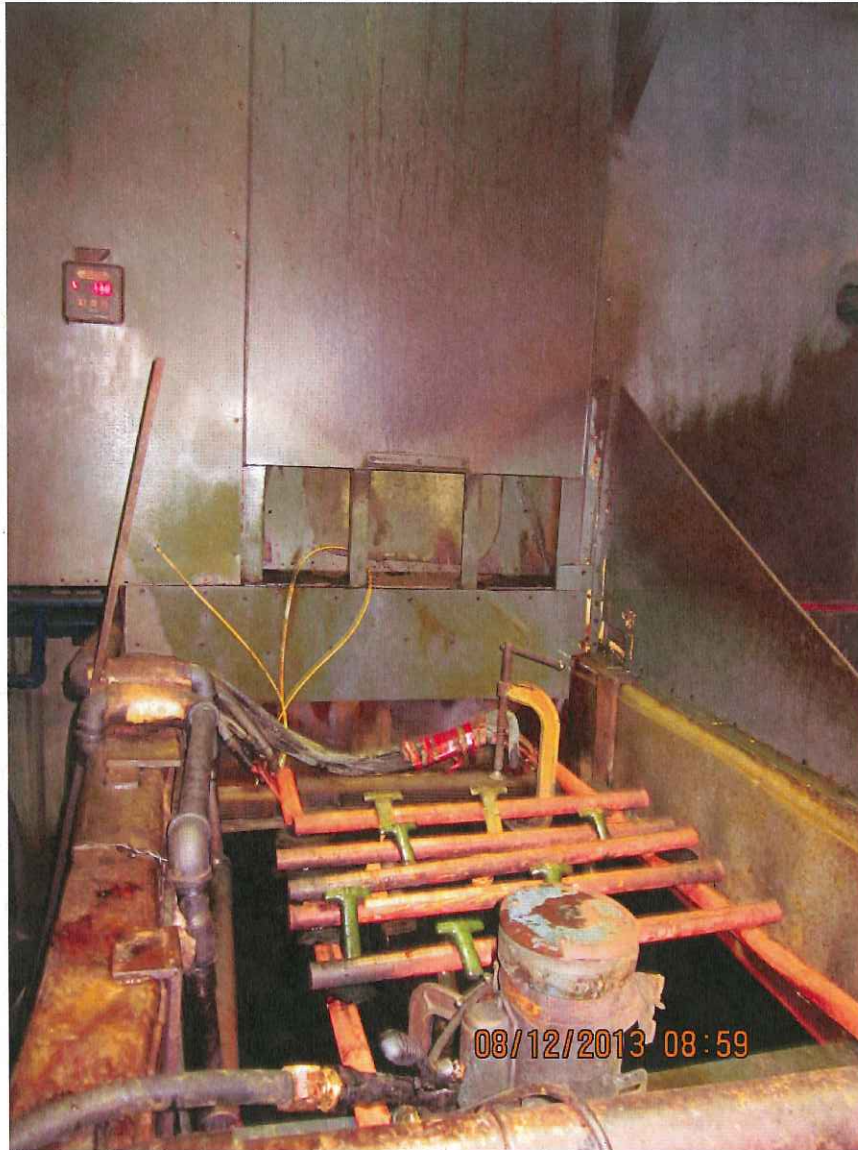
Photo 4: Tech Nickel's small chromium tank 'K.' Note the scrubber intake.

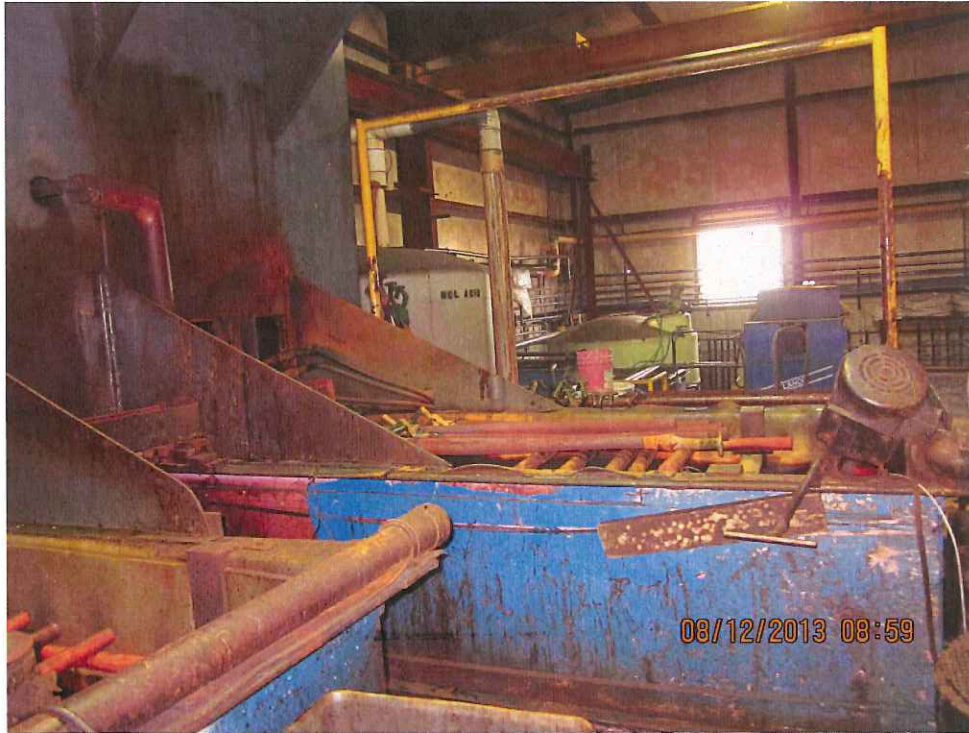
Photo 5: Tech Nickel's large chromium tank 'L.' Note the scrubber intake on the large chromium tank. The small chromium tank is in the foreground.

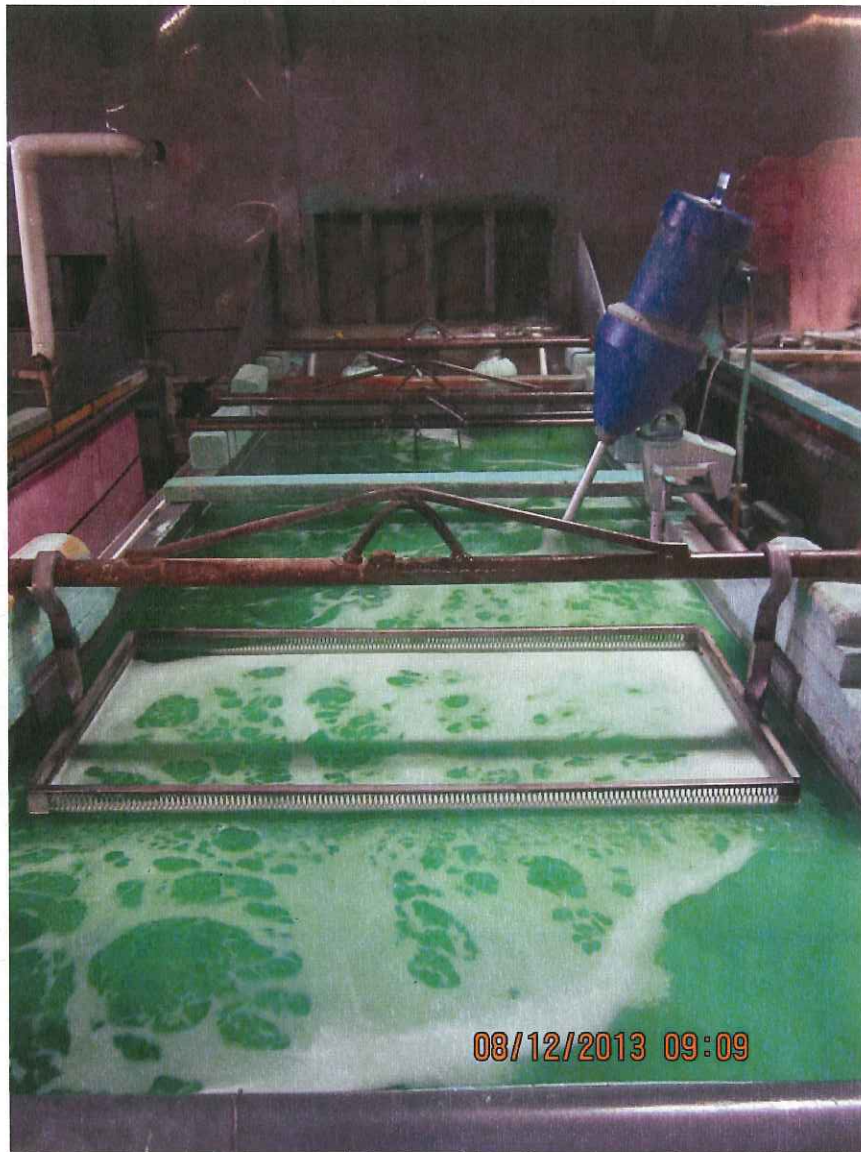
We continued along the plating line, stopping at the nickel tanks. First, Ms. Brahmabhatt and I viewed the empty electroless nickel tank. Mr. Vogl pointed out the operational electroless nickel tank directly next to the empty nickel tank (Photo 7). Mr. Vogl also pointed out the hot water rinse tank for the electroless nickel line.

Photo 7: Tech Nickel's electroless nickel tank. Note the scrubber intake.

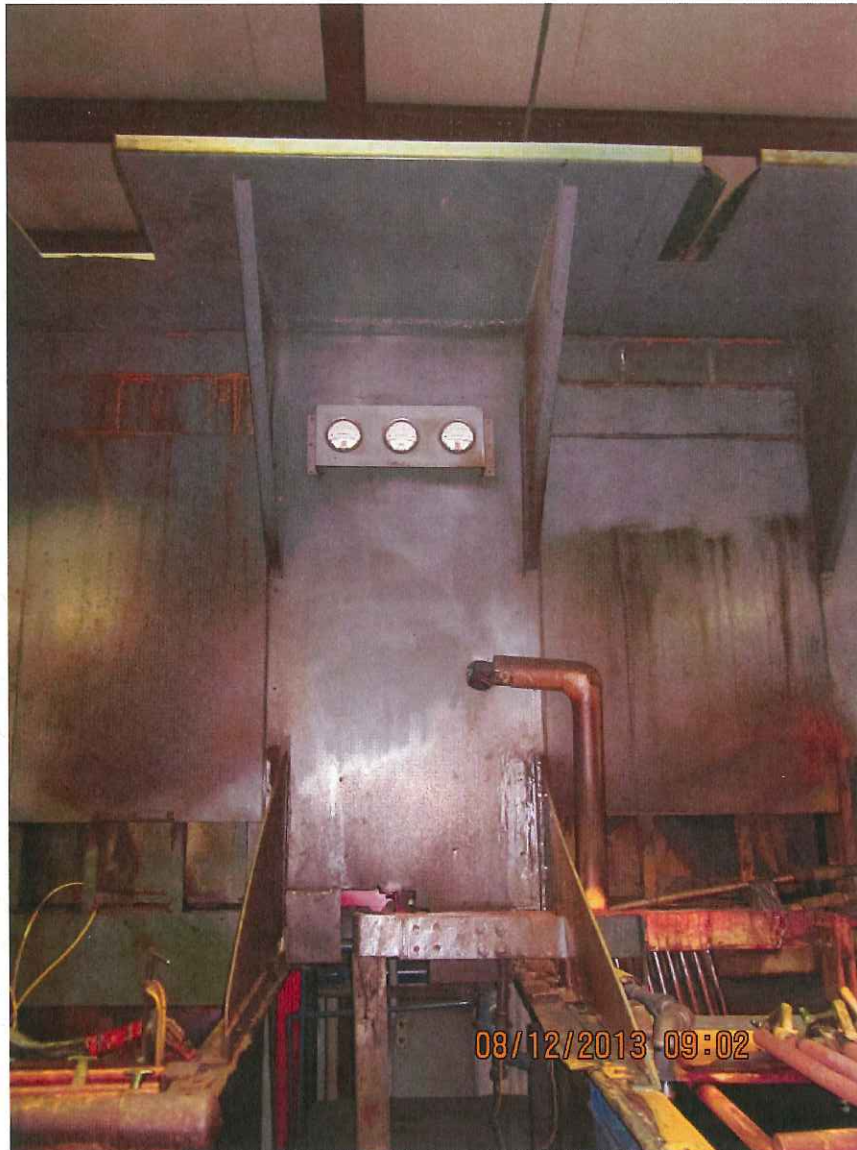
Ms. Brahmbhatt asked Mr. Vogl what actions Tech Nickel takes when it exceeds its permitted pressure drop range. Mr. Vogl stated that Tech Nickel changes the scrubber pads when it gets close to 2.7". Ms. Brahmbhatt and I asked Mr. Vogl to provide the date of the last stack test. Mr. Vogl stated the last stack test was performed in 1998 and performs quarterly inspections. Mr. Vogl stated that the scrubber is flushed daily. Ms. Brahmbhatt and I asked if Mr. Vogl keeps a wetting agent additions log. Mr. Vogl stated that Tech Nickel does not record surfactant additions and that additions are made based on observation of conditions in the plating tanks.

Photo 6: Tech Nickel's Magnehelic Gages for the chromium scrubber. The gages were approximately 10 feet from the ground.

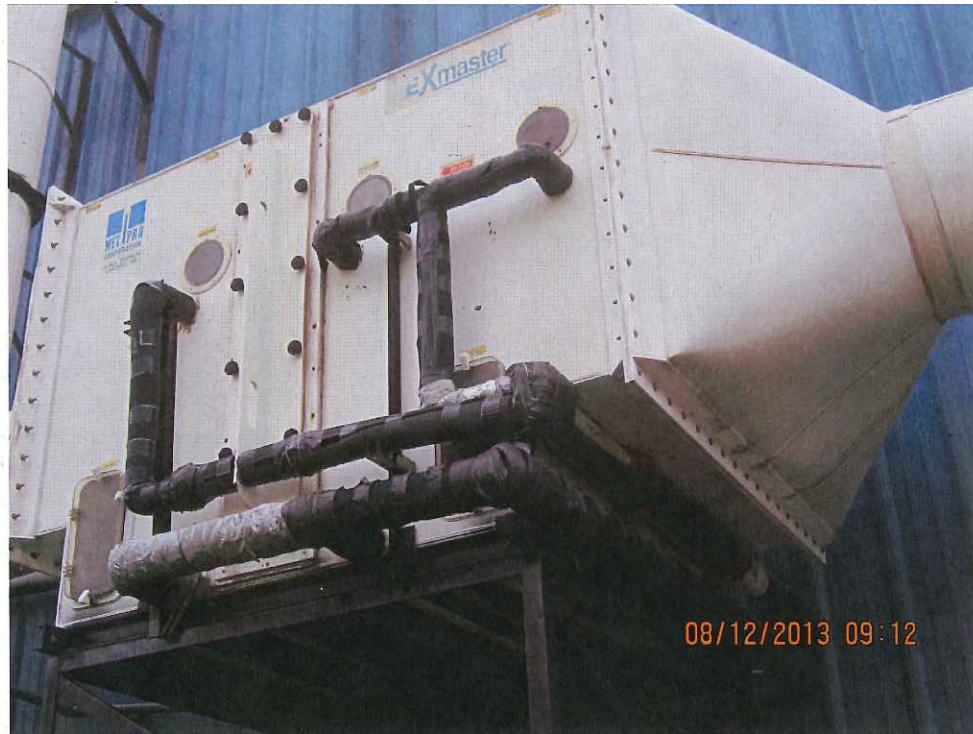
Mr. Vogl asked if we wished to see the scrubbers. Ms. Brahmabhatt and I stated that we would like to observe them. Mr. Vogl led us past the chromium line and outside the building to view the scrubbers. Mr. Vogl stated that Tech Nickel has three scrubbers, one each for the hydrochloric acid, nickel and chrome operations. Ms. Brahmabhatt and I observed the scrubbers to be in poor condition. We observed different types of tape wrapping most the intake tubes feeding into the scrubber (Photo 8 and 9).

Photo 8: One of Tech Nickel's scrubbers. Note the condition of the scrubber with exposed insulation and duct tape.

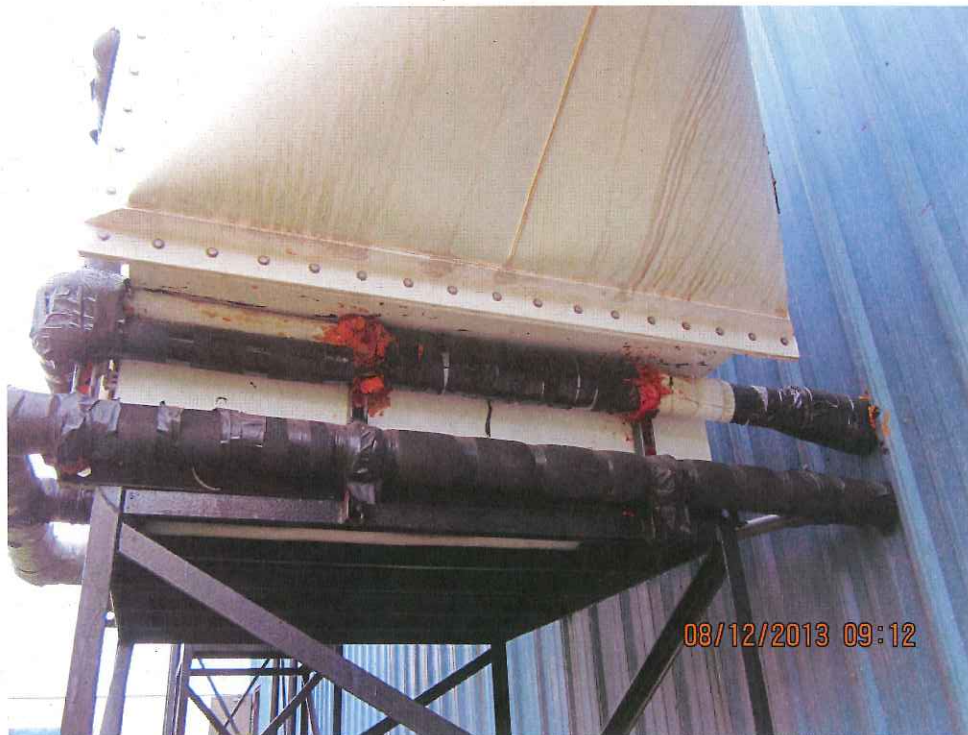
Photo 9: A close up of the condition of one of Tech Nickel's scrubbers. Note the c exposed insulation and duct tape.
